FINAL REPORT
R3189-01R

EFFECT OF HIGH CP POTENTIALS ON PIPELINES

PRCI CONTRACT NO. PR-186-02107
US DOT CONTRACT NO. DTRS56-03-T-0004

PREPARED BY
CC TECHNOLOGIES LABORATORIES, INC.
MARK YUNOVICH, MS, MBA, NACE CORROSION SPECIALIST
BRETT TOSSEY, BS

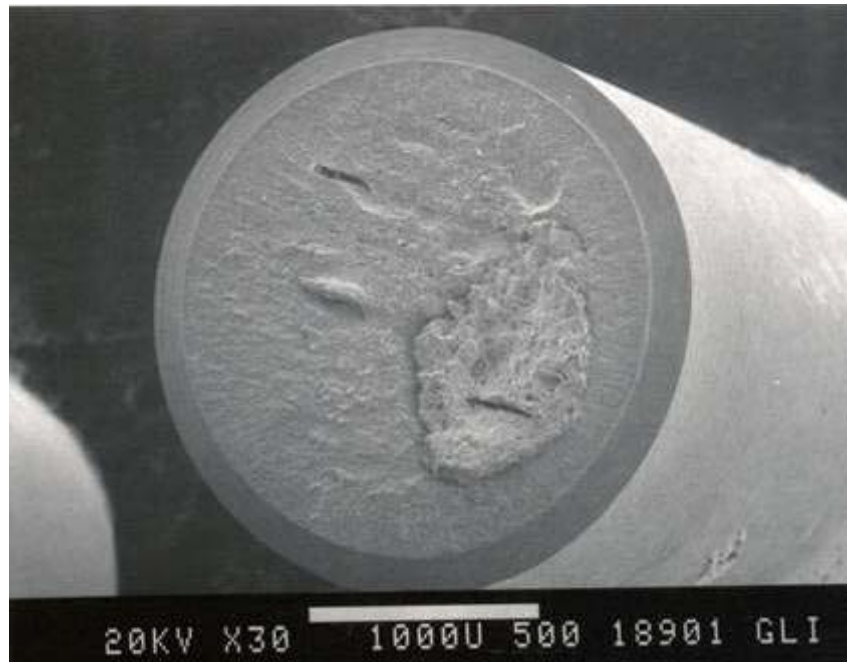
Figure 11. X65(HC) steel, 200 mA/ft², 30X magnification. Note mostly brittle failure.

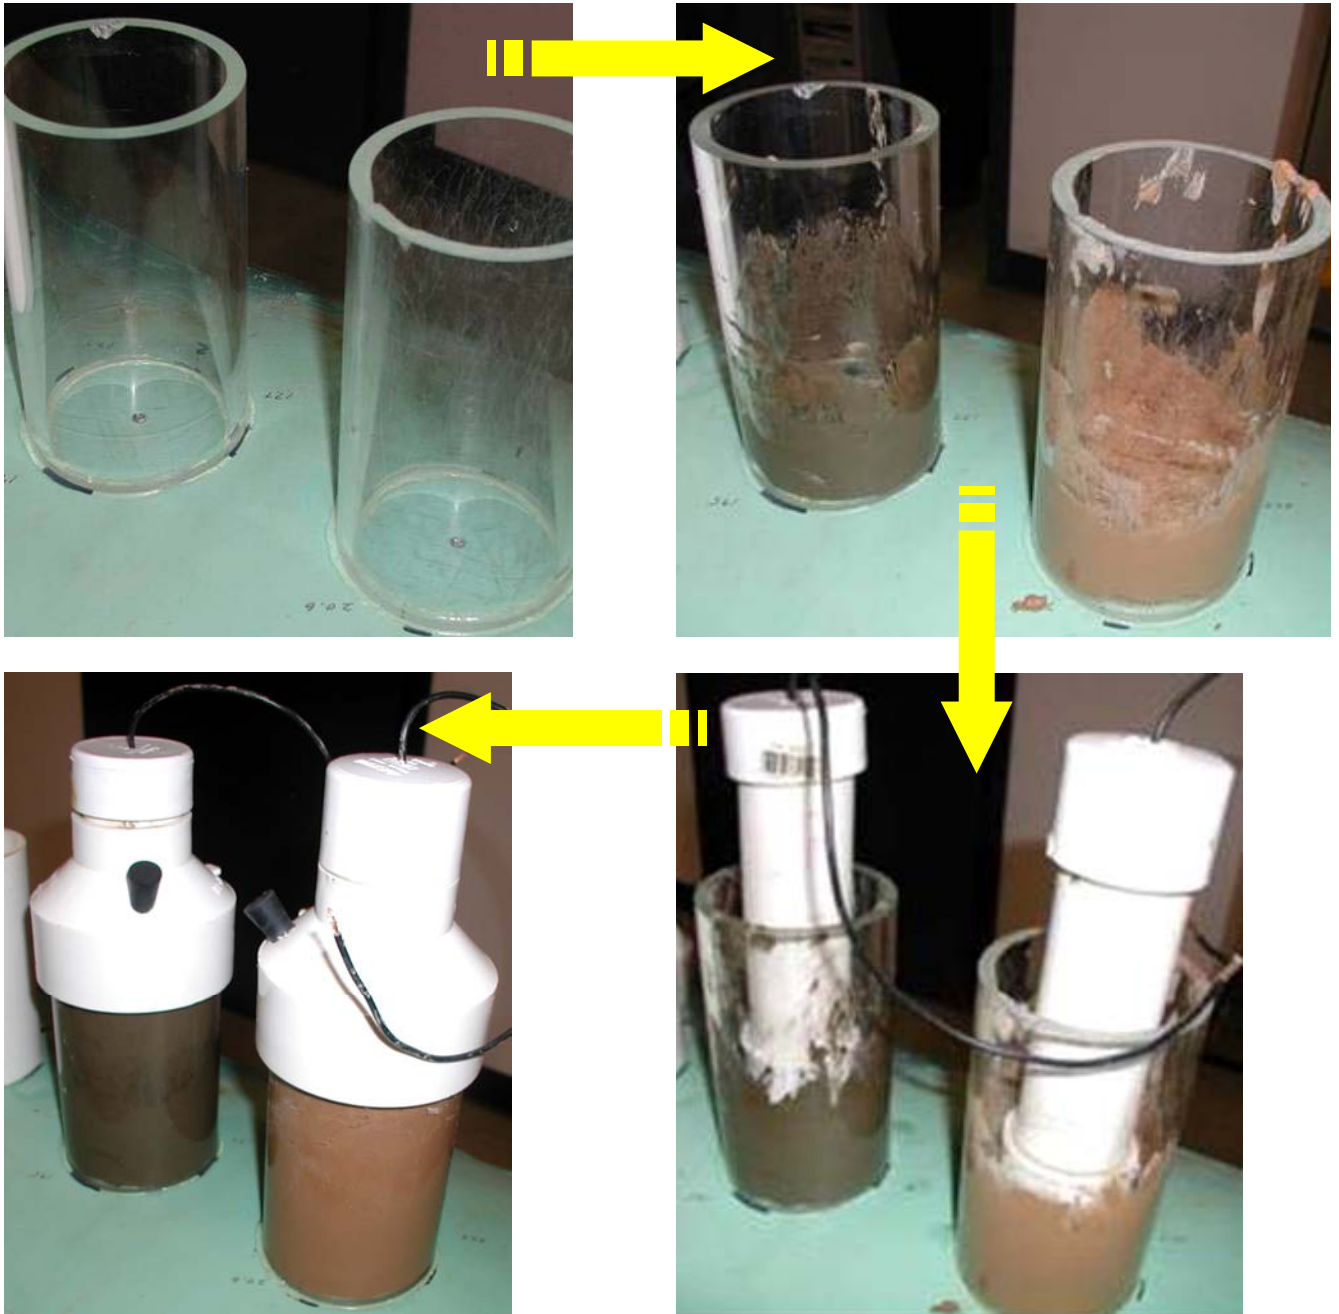
Figure 19. Test cell setup.

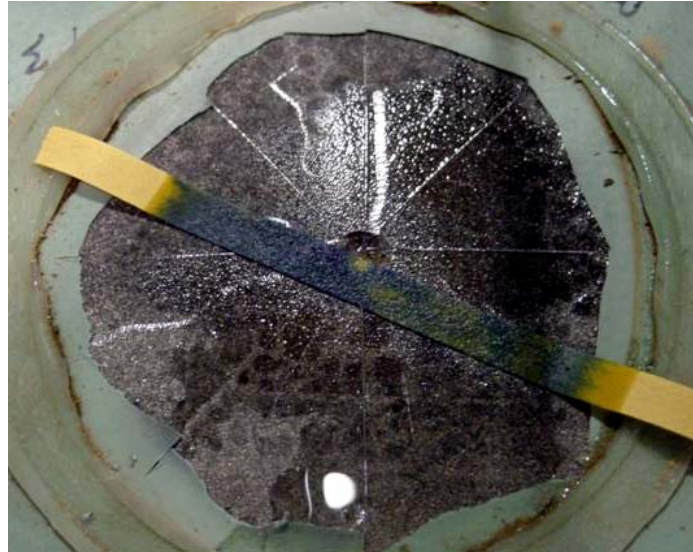
Figure 31. Elevated pH under disbonded coating in RNM soil at 200 mA/ft². Deep blue color indicates pH of 11-12+.

Experimental observations show that, at higher applied current densities, pH was significantly elevated (estimated at 11-12+ using indicator paper – see Figure 31 for an illustration). The ordinates (y-axes) are in reference to a standard hydrogen electrode (SHE); to convert to saturated copper/copper sulfate (CSE) electrode, subtract 0.318V from the SHE potential value.

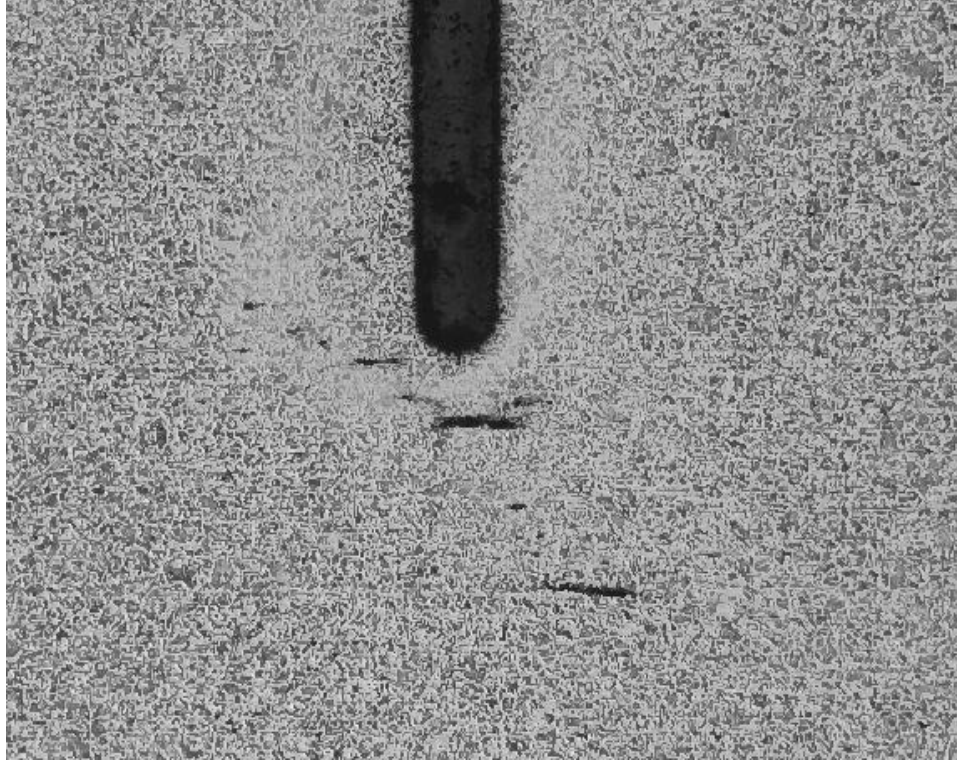
X65 (Vessel plate), 0.23%C, SOHIC, 25X magnification.
